Service report

# Willow Court Properties

Willow Court, 240 Example Avenue

| DATE | REPORT | TECHNICIAN |
|---|---|---|
| 2026-09-08 | EXAMPLE-1042 | Alex Morgan |

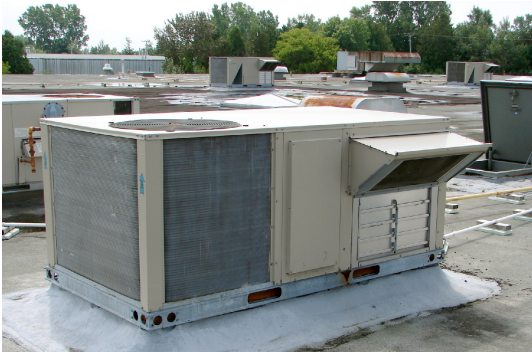
Filters were loaded with dust. Blower belt had visible cracking but remained intact. The correct replacement belt was not available during this visit.

| RTU-2 | Office to send a quote for belt replacement. Customer approval is pending; schedule the return visit once approved and the belt is available. |

Replaced four 20 × 25 × 2 in. filters and recorded the belt size for ordering. Confirmed fan and cooling operation; the existing belt remains installed.
